## STAR Case

**Case Number:** S1618000031

**Symptom/Vehicle Issue:** Customer may complain of a Mil-on condition accompanied by one or more DTCs set in the PCM related to the Accelerator Pedal Position Sensor (APPS).

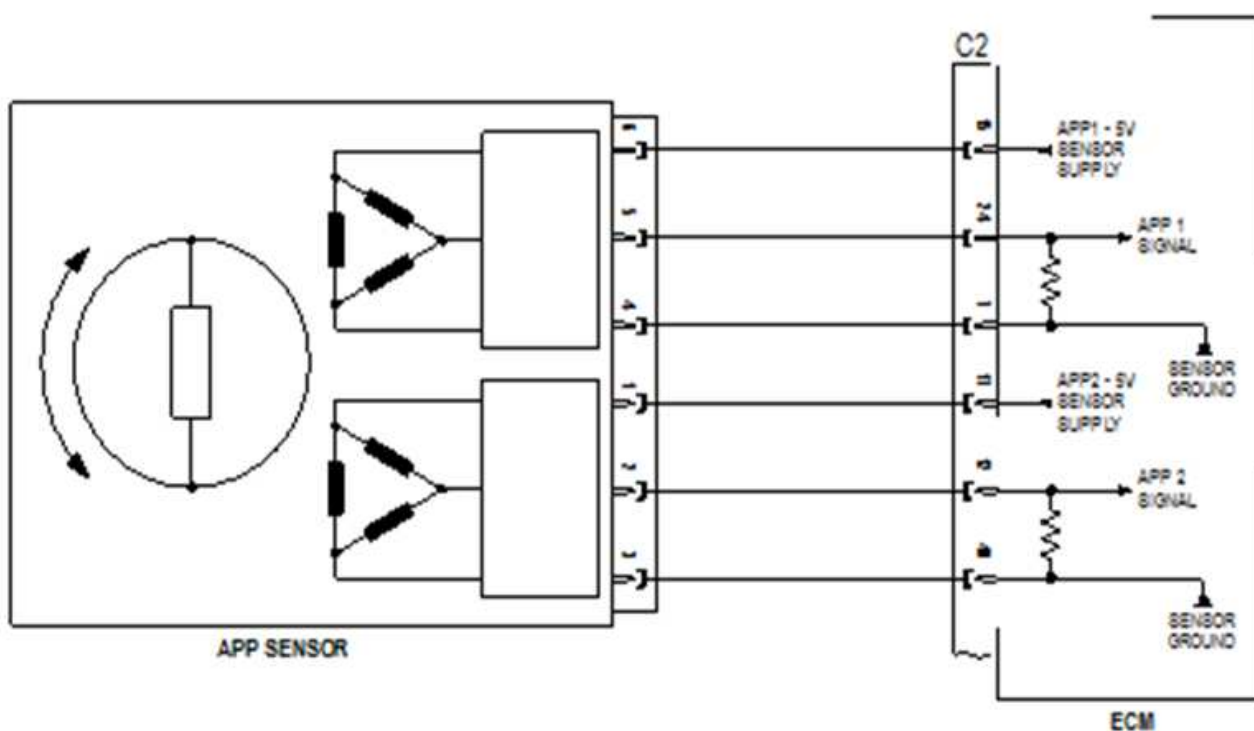
The APPS can be considered an assembly (accelerator pedal assembly). It contains 2 separate sensors that act together as the output or signal from the pedal assembly.

APPS1 and 2 each have their own separate 5 volt supply, signal and signal return (ground) circuits.

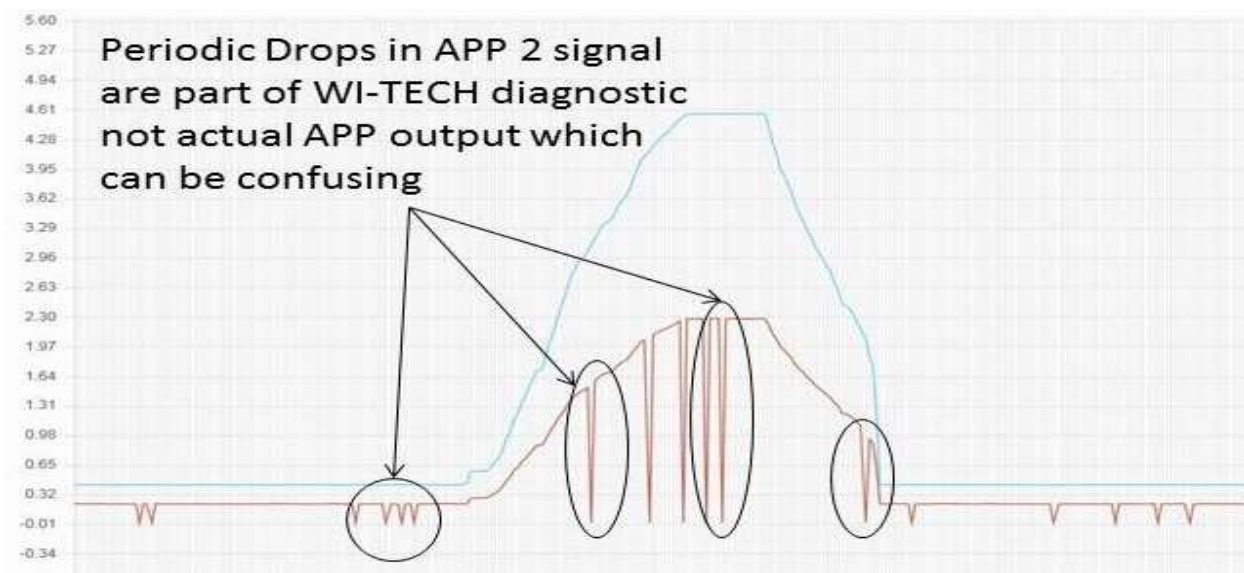
A “normal” APPS1 and 2 signal output is shown below with a “good” APPS assembly.

APPS2 (Red) periodic drops to 0v is normal. This characteristic is part of the WiTech diagnostic and should not be considered a reason to replace the APPS assembly.
