SERVICE BULLETIN

Classification: EL05-012	Reference: NTB05-053	Date: June 29, 2005
-----------------------------	-------------------------	------------------------

2002 - 2005 ALTIMA; MIL ON WITH DTCs STORED P0444, P0447, P0605, P1122, P1444, P1490

APPLIED VEHICLE: 2002 – 2005 Altima (L31)

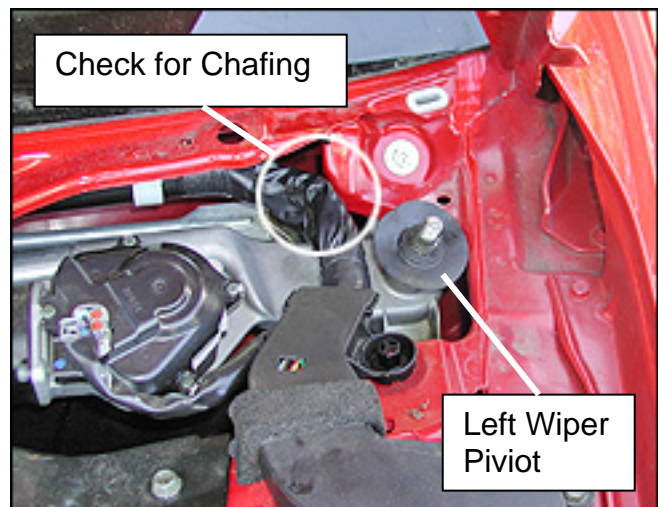
Figure 1

- Check the Engine Room Harness for “chafing” (wire insulation has rubbed through).

NOTE: The area to check is located at the left side (driver side) bulkhead near the left wiper pivot.

- If chafing/damage is found, repair or replace the harness.

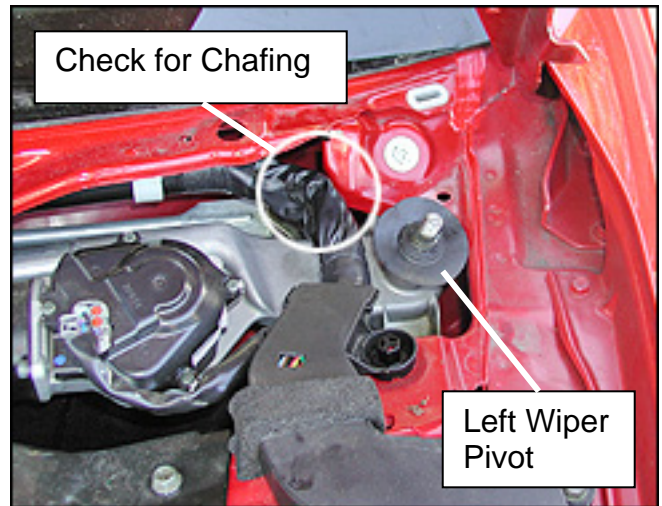
2. With the plastic cowl top removed, inspect the Engine Room Harness in the area shown in Figure 2 for chafing.

- #### b. If there is chafing/wire damage, count how many wires are damaged.

- 1 to 4 wires damaged; repair each damaged wire using the Flameless Heat Gun J-46538 and Solder Sleeve Connectors (see NTB03-078).

- 5 or more wires damaged; replace the Engine Room Harness.
 - Refer to section PG in the ESM for Engine Room Harness replacement information.
