#PI1296: DIAGNOSTIC TIP FOR E...**#PI1296: DIAGNOSTIC TIP FOR ENGINE MISFIRE AND/OR POPPING NOISE ON COLD STARTUP AFTER CYLINDER HEAD OR FUEL RAIL/INJECTOR REPAIR (AUG 19, 2014)**Document
ID# 3968014**#PI1296: DIAGNOSTIC TIP FOR ENGINE MISFIRE AND/OR POPPING NOISE ON COLD STARTUP AFTER CYLINDER HEAD OR FUEL RAIL/INJECTOR REPAIR (AUG 19, 2014)****Subject: Diagnostic Tip for Engine Misfire and/or Popping Noise on Cold Startup after Cylinder Head or Fuel Rail/Injector Repair**

**Models: 2009-2015 Buick Enclave Models
2010-2015 Buick LaCrosse, Allure (Canada)
2008-2011 Cadillac STS
2009-2015 Cadillac CTS Models
2010-2015 Cadillac SRX
2013-2015 Cadillac ATS, XTS
2009-2015 Chevrolet Traverse
2010-2015 Chevrolet Camaro, Equinox
2012-2015 Chevrolet Captiva, Impala
2015 Chevrolet Colorado
2009-2015 GMC Acadia Models
2010-2015 GMC Terrain
2015 GMC Canyon
2009-2010 Saturn OUTLOOK
Equipped with HFV6 Engine RPOs LF1, LFW, LFX, LLT, LF3 or LFR****Condition/Concern**

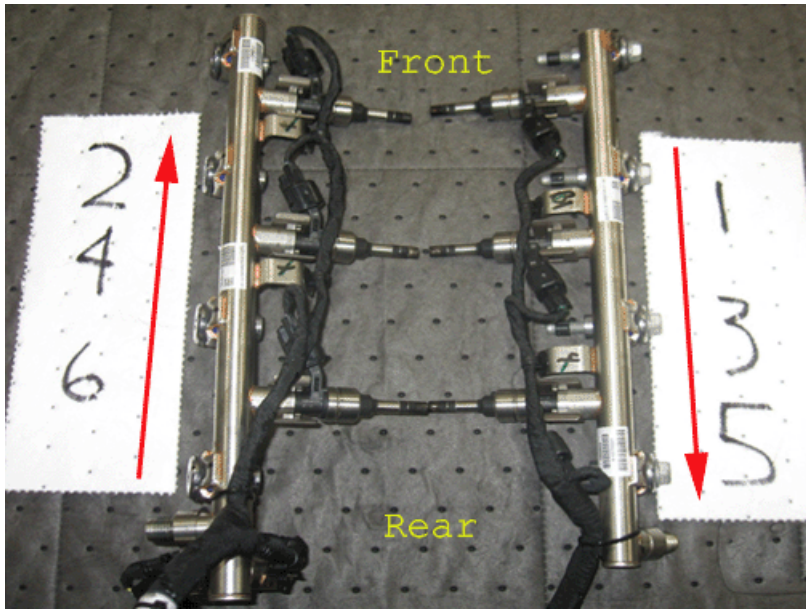
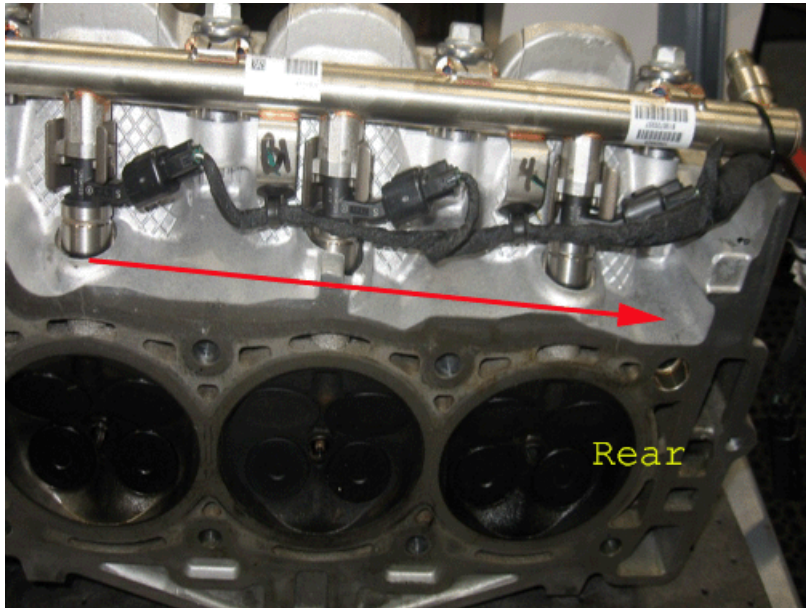
This may be caused by improper orientation of the fuel injectors due to the previous repair. The injector spray pattern is not in a circular shape, but an oval shape. An improperly installed injector redirects the ends of the oval spray pattern into the intake valve during valve overlap in the split pulse mode of a cold start. Once the split pulse injection start up process has completed it's duty cycle, the engine will operate normally until the next cold start event.

- Bank 1 injector connectors aim toward the rear of the engine as shown above.

Verify the orientation of the fuel injectors. Refer to Fuel Injector Fuel Rail Assembly Replacement in SI.

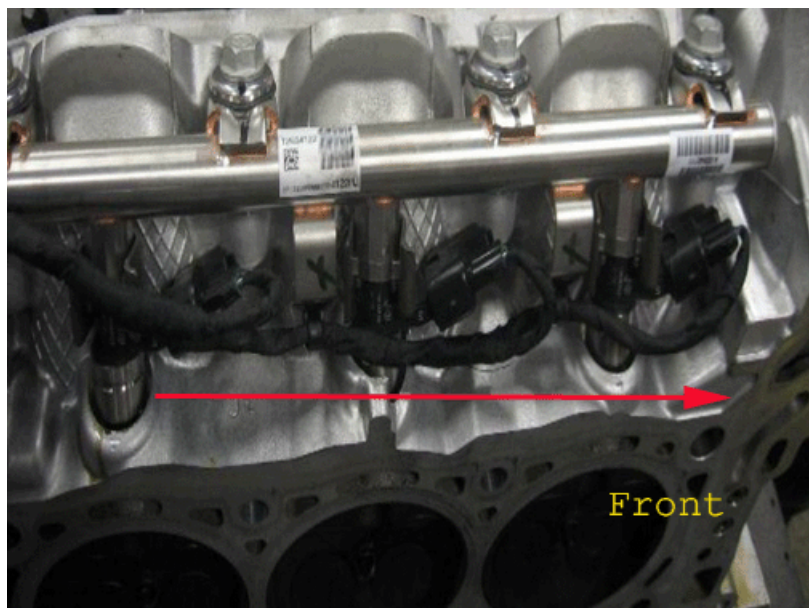
- Bank 2 injector connectors aim toward the front of the engine as shown above.
