#PIP5197H: Possible Oil Consumption - Oil Leaks - Blue Smoke From The Exhaust - Whistle Noise - MIL On - DTC P0171 - (Oct 17, 2018)

Subject: Possible Oil Consumption - Oil Leaks - Blue Smoke From The Exhaust - Whistle Noise - MIL On - DTC P0171

Brand:	Model:	Model Year:		VIN:		Engine:	Transmission:
		from	to	from	to		
Buick	Encore	2013-2019		All	All	LUJ and LUV	All
Chevrolet	Cruze	2011-2016		All	All	LUJ and LUV	All
Chevrolet	Sonic	2012-2019		All	All	LUJ and LUV	All
Chevrolet	Trax	2013-2019		All	All	LUJ and LUV	All

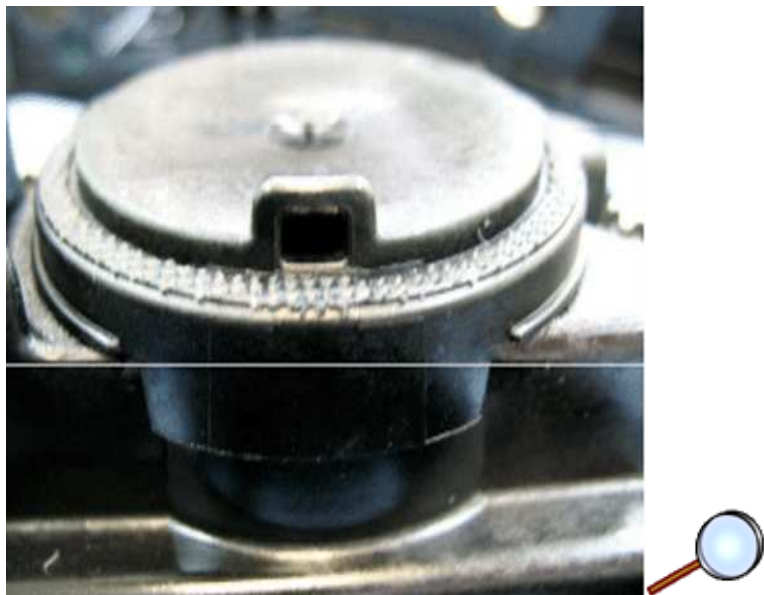
Check the PCV orifice for leaking oil or drawing vacuum at idle thru its external port. (The PCV orifice is an integral part of the camshaft cover). (See picture below).

It may also damage the PCV orifice diaphragm causing a P0171.

If the PCV orifice external port is leaking oil or vacuum, replace the camshaft cover assembly.

Clean oil from all induction system components and retest for oil consumption, leaks or DTCs resetting.

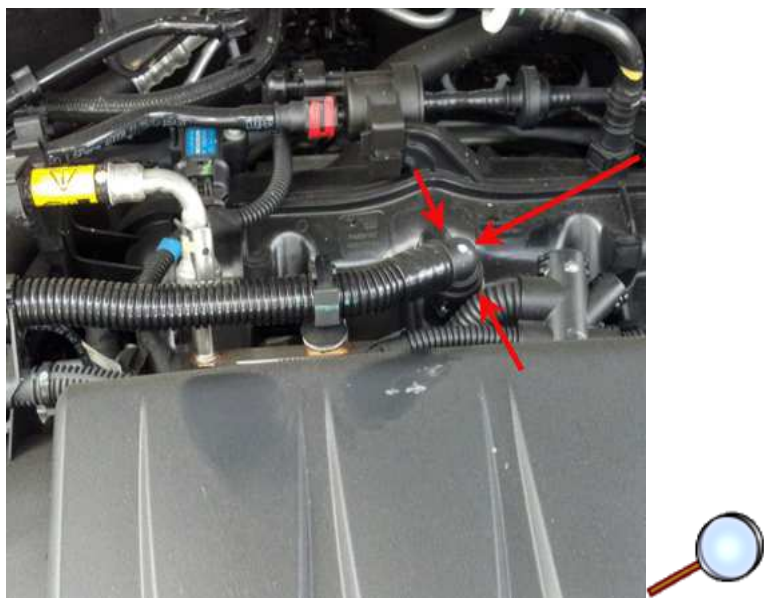
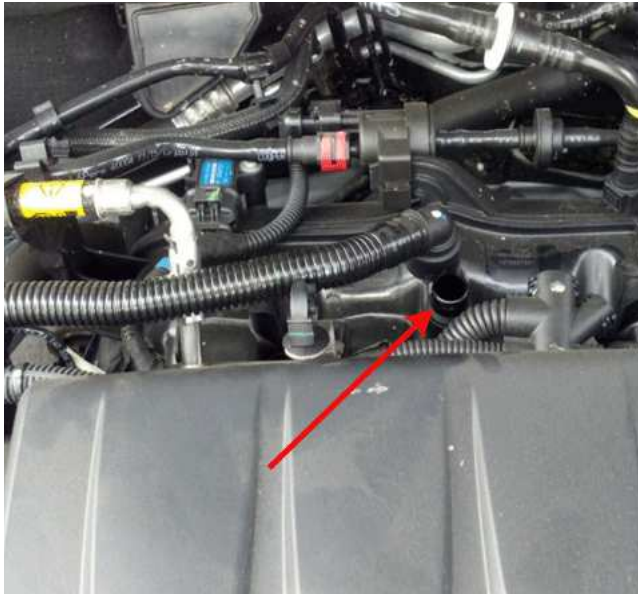
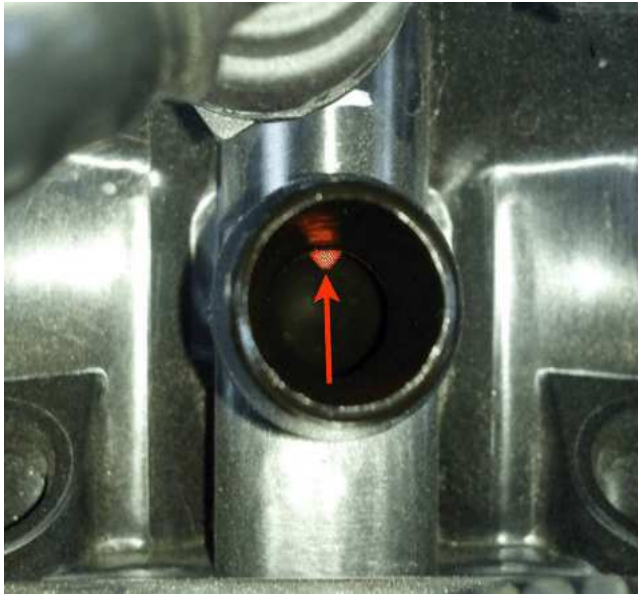
Check for a missing intake manifold Non Return Valve that may have damaged the PCV orifice diaphragm. (See pictures below for inspection procedure).

If the non return valve is not visible as shown in picture, then use a long cotton swab to wipe any excess oil from the valve to validate.

If the non return valve is still not visible, then intake manifold removal for inspection is required to validate.

If the valve is present reinstall the intake manifold. Do not replace.

If the intake manifold Non Return Valve is missing, then replace the intake manifold assembly, Clean oil from all induction system components and retest for oil consumption, leaks or DTCs resetting.

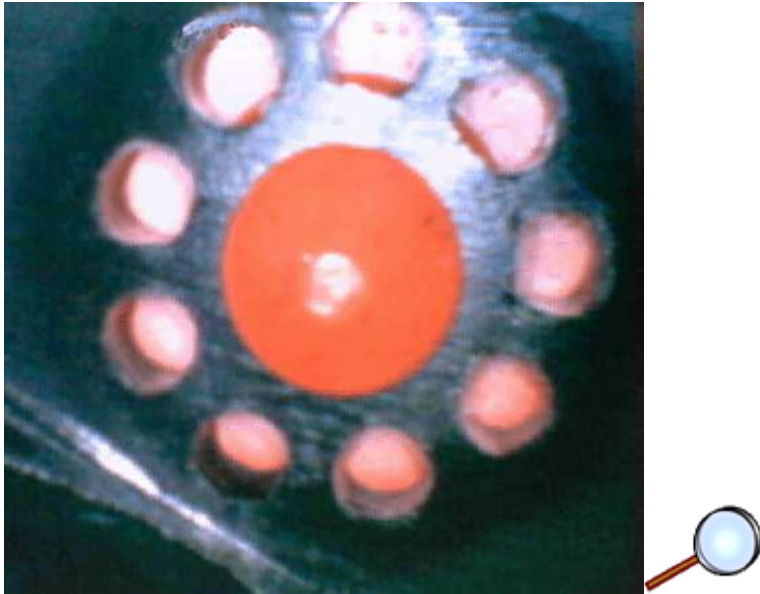
Properly seated Non Return Valve as viewed with the intake manifold removed.

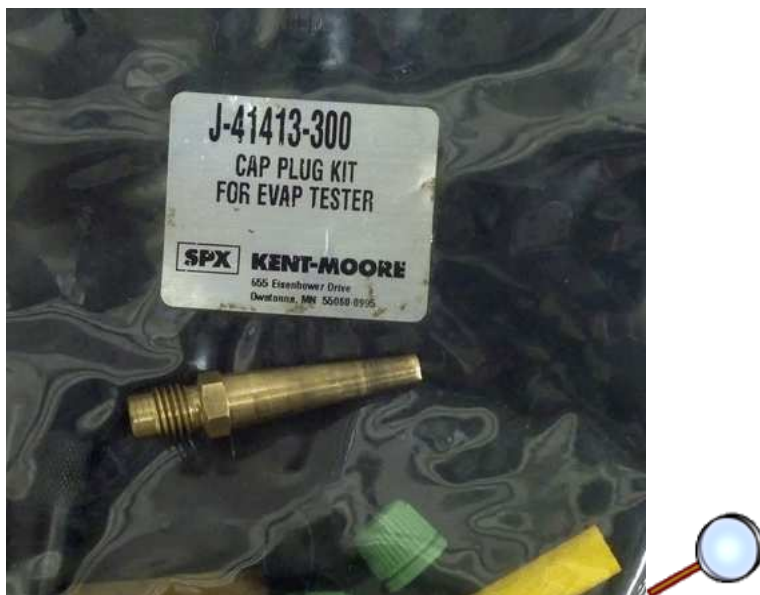
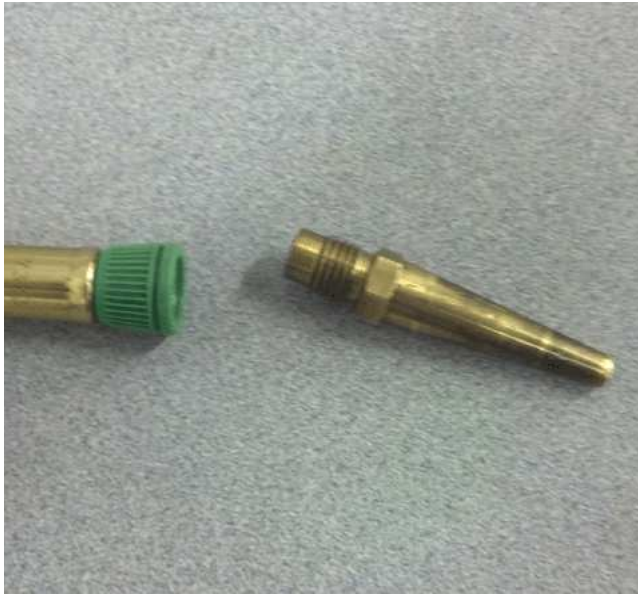
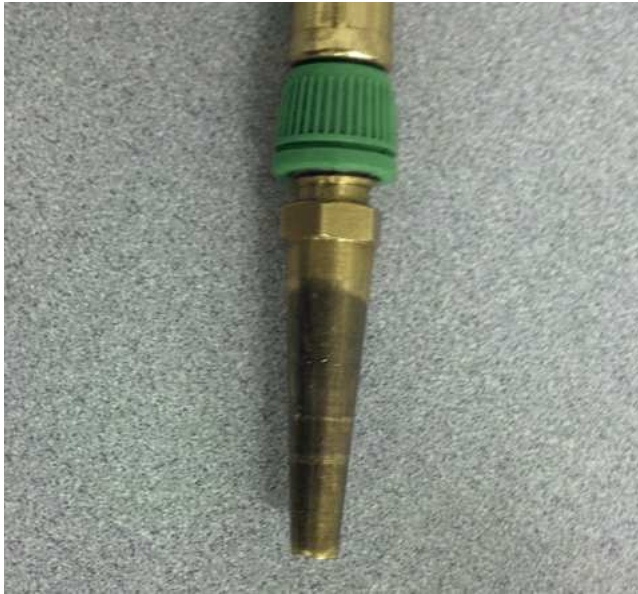
Record the crankcase pressure. (Normal crankcase pressure readings are between -11 & -18 inches of water in park at hot idle) / (ESST gage works best, see pictures below for connection of ESST at the engine oil dipstick hole in the camshaft cover.

Record the crankcase pressure at hot idle in park as well as under snap throttle.

Note: The connection must be made with the engine off. The engine is then started and the pressure readings are recorded.

If the crankcase pressure is between -11 and -18 inches of H₂O during the hot idle in park and during snap throttle testing, then clean oil from all induction system components and retest for oil consumption, leaks or DTCs resetting.

If the crankcase pressure is between -10 and 0 inches of water then a cylinder leakage / crankcase pressure concern exists.

This is likely caused by a weak or broken piston ring land.

Replace all four piston assemblies and retest for proper crankcase pressures.

Clean oil from all induction system components and retest for oil consumption, leaks or DTCs resetting.
