# Service Bulletin

Bulletin No.: PIP5197

**Subject:** Possible Oil Consumption - Oil Leaks - Blue Smoke From The Exhaust - MIL - Or Fuel Trim Codes

**Models:** 2012 - 2014 Chevrolet Cruze  
2013 - 2014 Buick Encore  
2013 - 2014 Chevrolet Sonic  
2013 - 2014 Chevrolet Trax (Canada Only)  
Equipped with 1.4L (RPO LUJ or LUV)

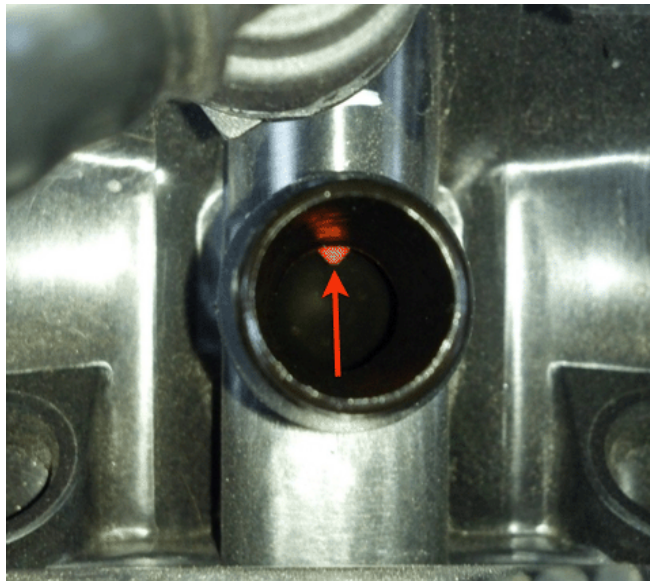
3814782

Properly seated Non Return Valve.

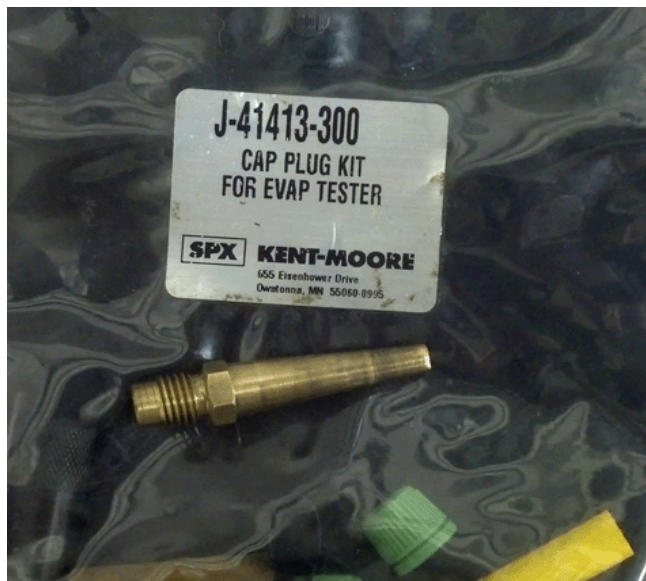
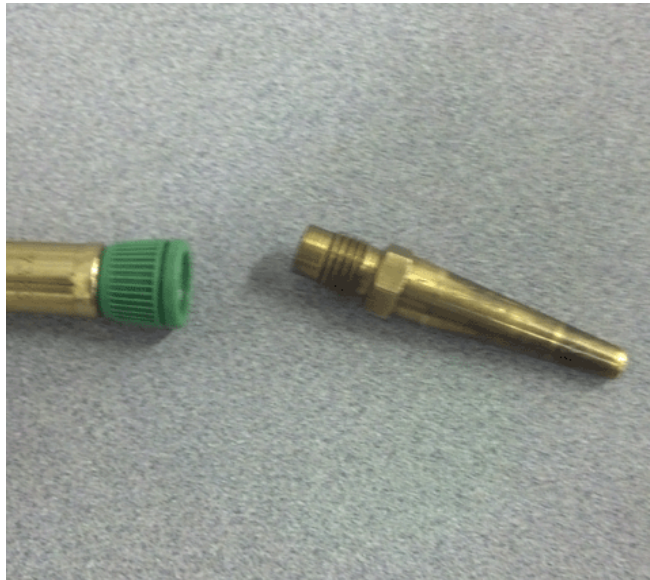
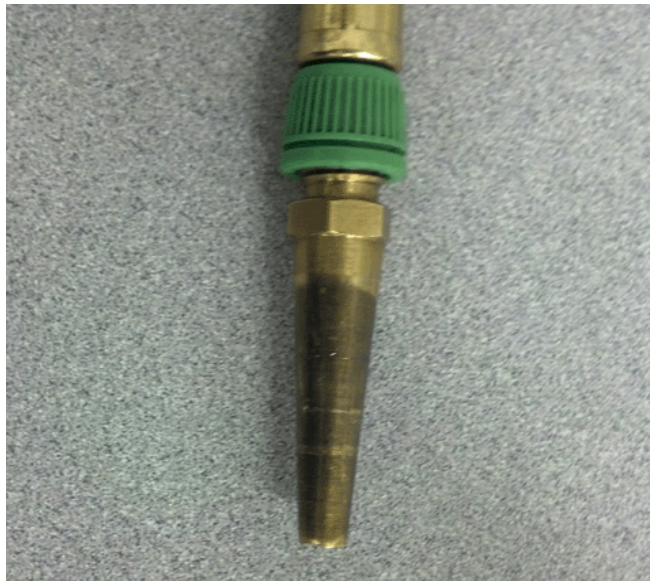
Record the crankcase pressure. (Normal crankcase pressure readings are between -11 & -18 inches of water in park at hot idle) / (ESST gage works best, see pictures below for connection of ESST at the engine oil dipstick hole in the camshaft cover).

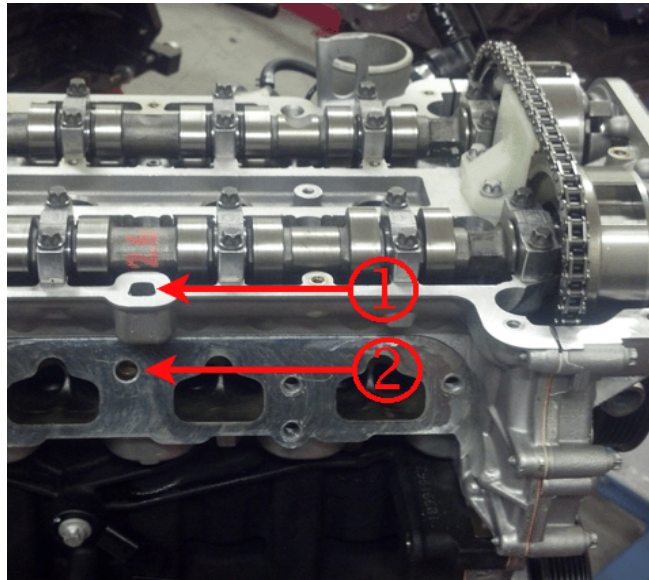
3684807

If the crankcase pressure is excessively negative, below -30 inches of water (-2 inches of HG / vacuum) the PCV port thru the cylinder head (Shown in the picture below between #1 and #2) may have a porosity issue causing intake vacuum to leak into the crankcase.

Plug the PCV port on the cylinder head at #2.

Fill the PCV port with a suitable liquid until full at #1.

Monitor the level of the liquid for fluid loss indicating porosity in the port.

If the fluid level drops, replace the cylinder head and retest for proper crankcase pressures.
