## # PIP5038B: SES Light, Engine Misfire, and/ or Shudder - Inspect Ignition Coils - (Jun 4, 2013)

Subject: SES Light, Engine Misfire, and/ or Shudder - Inspect Ignition Coils

Models: 2009 Buick Enclave  
2008-2009 Cadillac CTS, STS  
2009 Chevrolet Traverse  
2009 GMC Acadia  
2009 Saturn Outlook  
With Direct Injected 3.6L V6 Engine (RPO LLT)

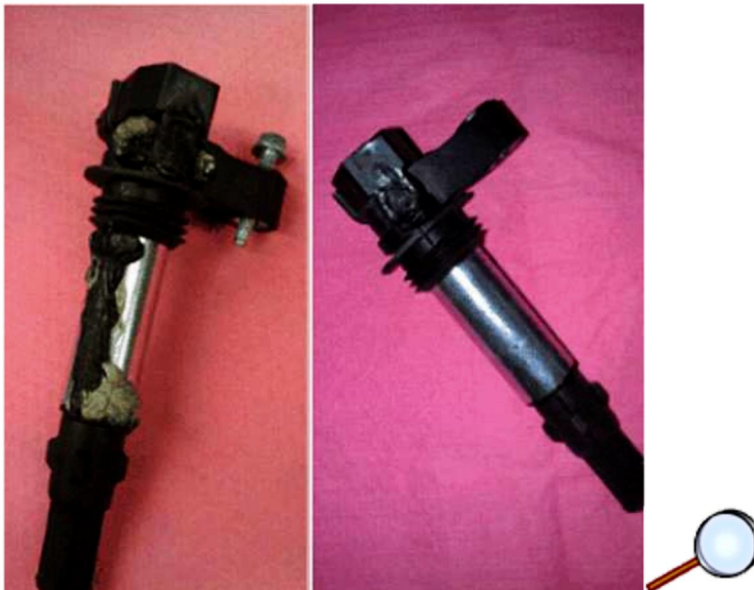
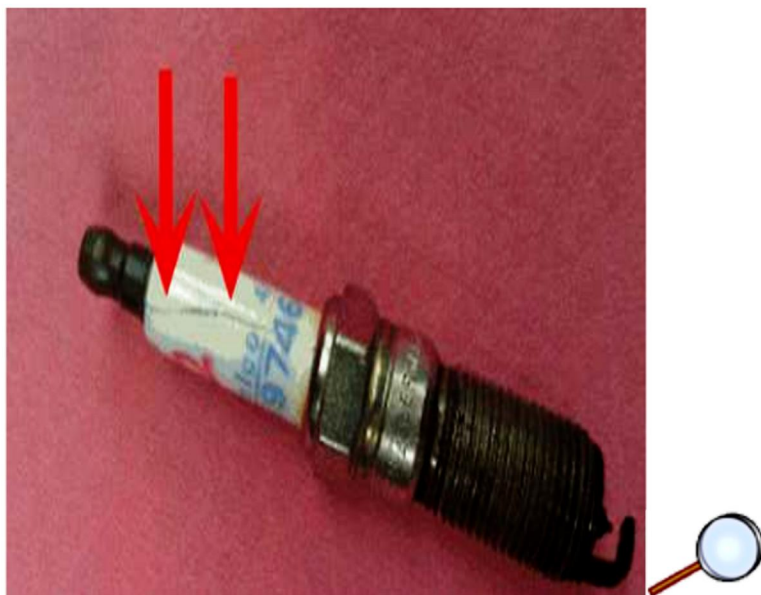
This may be the result of a heat stressed/damaged ignition coil.

The coil damage could be due to the ECM latching "ON" the associated coil EST (dwell) line.

Dwell times greater than 50msec will result in coil damage (see photos)

**Note:** The cylinder with the damaged coil may not be the cylinder causing the issue (coil damage).

ECM EST latchup is caused by an Electromagnetic Interference (EMI) that is conducted from the ignition coil to the ECM on one of the EST lines (wire to wire coupling of this electrical transient is not the issue). The ignition coil/cylinder that is producing this EMI may not be the one that is damaged. Eliminating the source of this issue, not just replacing the damaged ignition coil is key to having customers not return with the same condition.

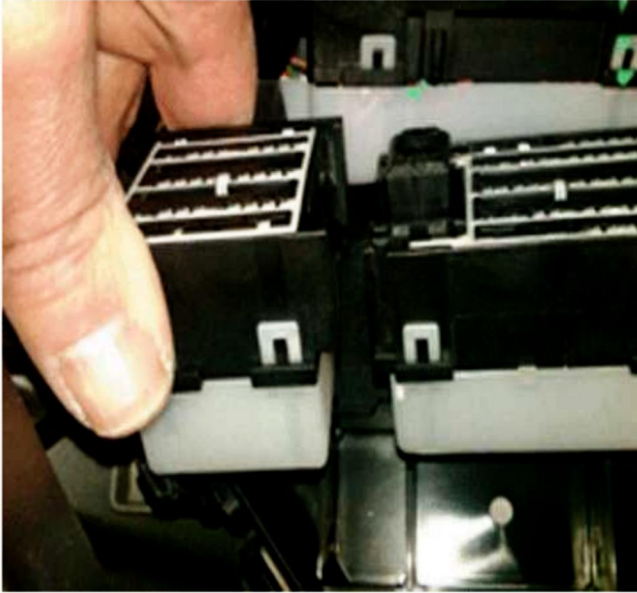
Incomplete connector engagement into the base of the UBEC can cause intermittent conditions for many engine circuits.

U BEC (Under Hood Body Electrical Center) - Poor connector engagement on bottom of the UBEC, loose terminal fits and low pin drag can cause intermittent transient.

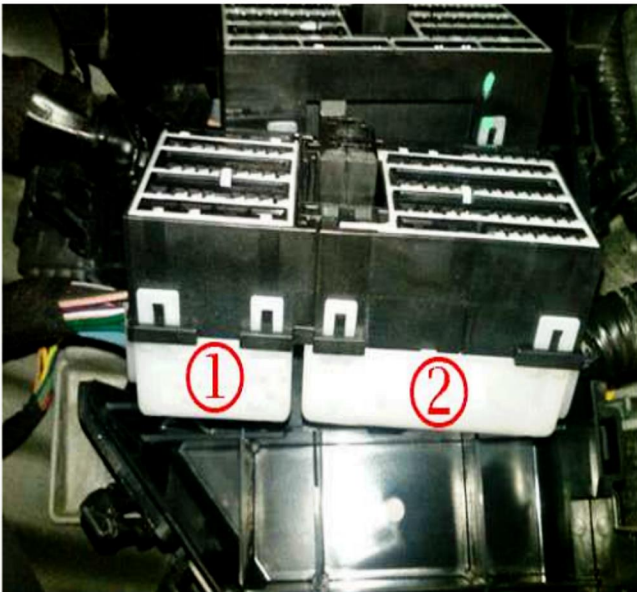
1) Connector 1 2) connector 3

X1 and X3 Connectors slide together. Connectors must be fully seated.

Check Coil terminal cavities for proper pin drag and fit.
