# Service Bulletin

Bulletin No.: PIP5197

**Subject:** Possible Oil Consumption - Oil Leaks - Blue Smoke From The Exhaust - MIL - Or Fuel Trim Codes

**Models:** 2012 - 2014 Chevrolet Cruze  
2013 - 2014 Buick Encore  
2013 - 2014 Chevrolet Sonic  
2013 - 2014 Chevrolet Trax (Canada Only)  
Equipped with 1.4L (RPO LUJ or LUV)

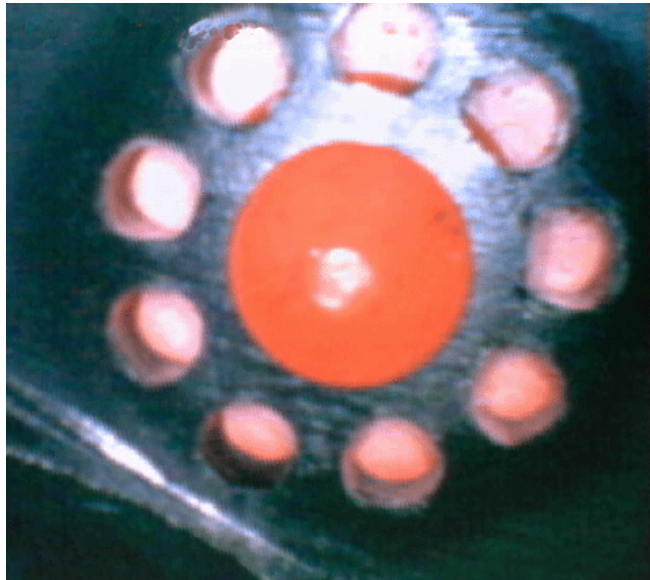
3814784

Properly seated Non Return Valve.

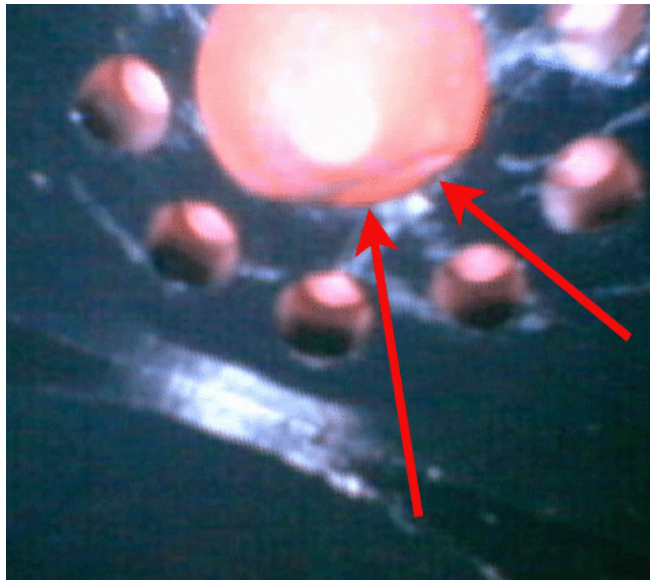
3814785

Improperly seated Non Return Valve.

If the intake manifold Non Return Valve is missing or not properly seated, then replace the intake manifold assembly, Check the PCV orifice for leaking oil or drawing vacuum at idle thru its external port. (The PCV orifice is an integral part of the camshaft cover). (See picture below).

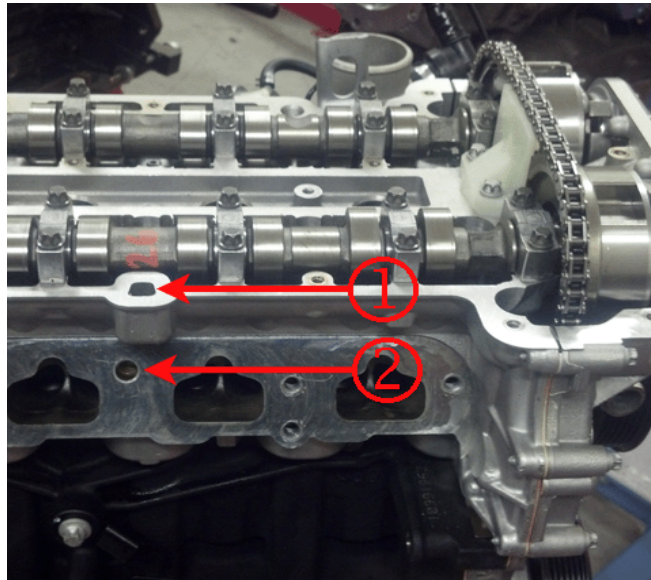
3684807

If the crankcase pressure is excessively negative, below -30 inches of water (-2 inches of HG / vacuum) the PCV port thru the cylinder head (Shown in the picture below between #1 and #2) may have a porosity issue causing intake vacuum to leak into the crankcase.

Plug the PCV port on the cylinder head at #2.

Fill the PCV port with a suitable liquid until full at #1.

Monitor the level of the liquid for fluid loss indicating porosity in the port.

If the fluid level drops, replace the cylinder head and retest for proper crankcase pressures.
