# VSC System DTC C1234: Yaw Rate Sensor

YEAR(S)	MODEL(S)	ADDITIONAL INFORMATION
2001 - 2002	Sequoia

Some 2001 – 2002 model year Sequoia vehicles may exhibit intermittent VSC activation. After the activation, Diagnostic Trouble Code (DTC) C1234 is stored in the skid control Electronic Control Unit (ECU) memory. Follow the Repair Procedure in this bulletin to address this condition.

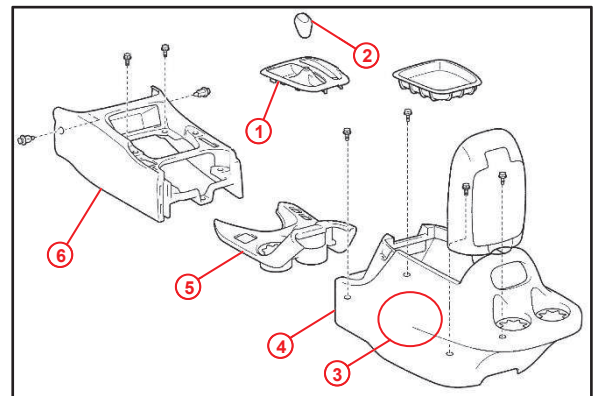
Figure 1.

1	4WD: Shifting Hole Cover
2	4WD: Shifting Lever Knob
3	Yaw Rate Sensor Location
4	Rear Console Box
5	Upper Console Panel
6	Front Console Box

3. Remove the console box.  
Refer to TIS, applicable model and model year Repair Manual:
