# Gas Cap "No Click" and/or "No Spring Return"

**Service Category** Engine/Hybrid System

**Section** Fuel System

YEAR(S)	MODEL(S)	ADDITIONAL INFORMATION
2014 - 2016	Corolla

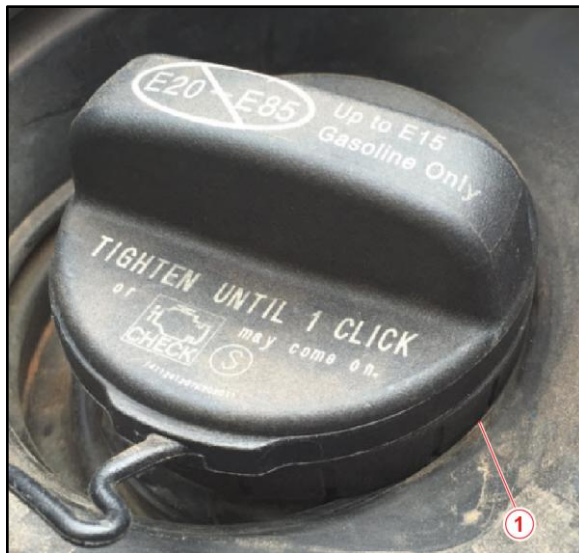
**Figure 1. NG Condition**

- **YES** – Continue to step B.
    - **NO** – This bulletin does NOT apply. Continue diagnosis using the applicable Repair Manual.
  - B. Does the fuel filler neck exhibit contact with the fuel shield? (See Figure 1.)
    - **YES** – Continue to step 2.
    - **NO** – This bulletin does NOT apply. Continue diagnosis using the applicable Repair Manual.

<b>1</b>	Contact with fuel shield
----------	--------------------------

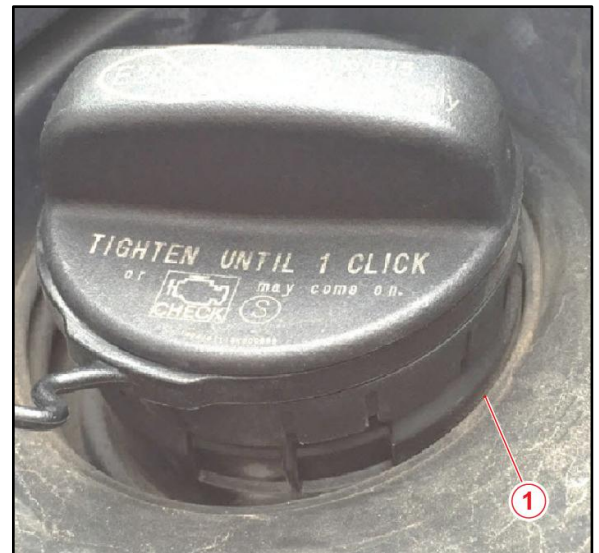
**Figure 2. OK Condition**

<b>1</b>	No contact with fuel shield
----------	-----------------------------

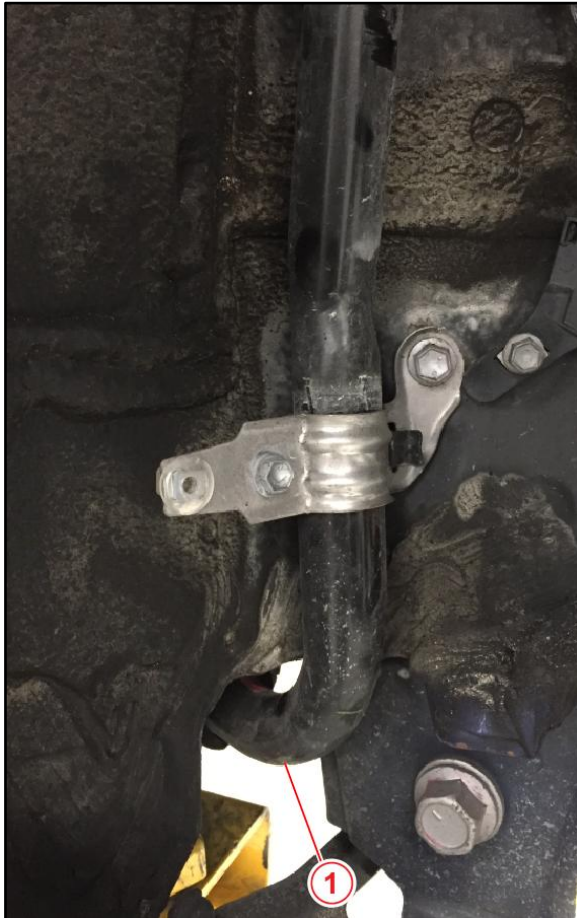
**Figure 5. Bottom Joint**

5. Reposition filler neck so opening protrudes further outside of the body.
  - A. Firmly Press Up from the bottom joint while pulling outward on the fuel neck opening.

<b>1</b>	<b>Press up</b>
----------	-----------------

- B. While holding in the raised position tighten the lower 10mm bolt.
  - C. Tighten the remaining 12mm and 10mm bolts.

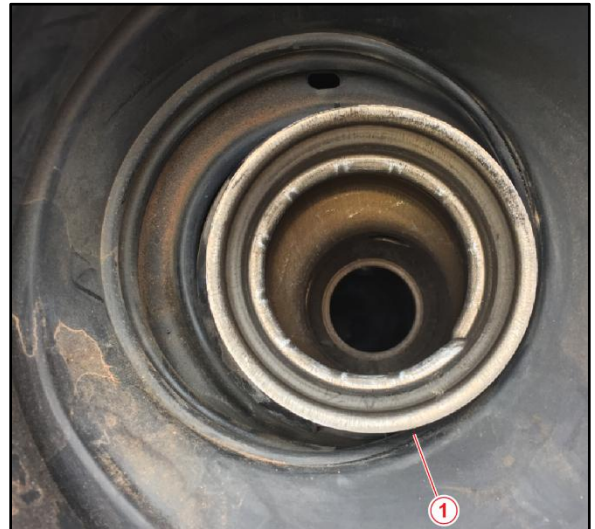
**Figure 6. Fuel Neck Opening**

<b>1</b>	<b>Pull out</b>
----------	-----------------

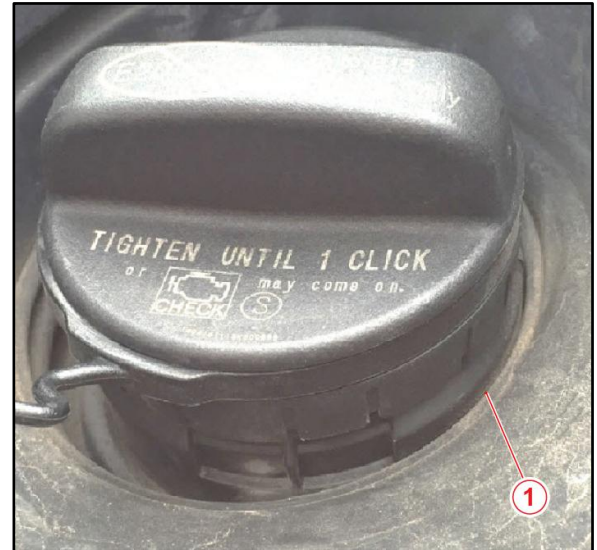
**Figure 7. OK Condition**

6. Verify filler neck is now protruding from body panel and fuel cap is not making contact with the fuel shield.

<b>1</b>	<b>No contact with fuel shield</b>
----------	------------------------------------
