# Service Bulletin

Bulletin No.: PIP5197

**Subject:** Possible Oil Consumption - Oil Leaks - Blue Smoke From The Exhaust - MIL - Or Fuel Trim Codes

**Models:** 2012 - 2014 Chevrolet Cruze  
2013 - 2014 Buick Encore  
2013 - 2014 Chevrolet Sonic  
2013 - 2014 Chevrolet Trax (Canada Only)  
Equipped with 1.4L (RPO LUJ or LUV)

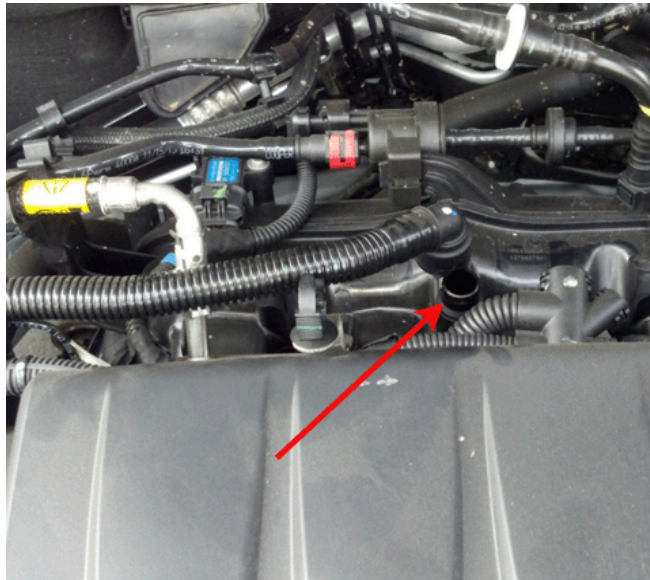
3814780

Check for a missing or improperly seated intake manifold Non Return Valve that may have damaged the PCV orifice diaphragm. (See pictures below for inspection procedure).

If the intake manifold Non Return Valve is missing or not properly seated, then replace the intake manifold assembly, Check the PCV orifice for leaking oil or drawing vacuum at idle thru its external port. (The PCV orifice is an integral part of the camshaft cover). (See picture below).
