# Service Bulletin

Bulletin No.: PIP5197

**Subject:** Possible Oil Consumption - Oil Leaks - Blue Smoke From The Exhaust - MIL - Or Fuel Trim Codes

**Models:** 2012 - 2014 Chevrolet Cruze  
2013 - 2014 Buick Encore  
2013 - 2014 Chevrolet Sonic  
2013 - 2014 Chevrolet Trax (Canada Only)  
Equipped with 1.4L (RPO LUJ or LUV)

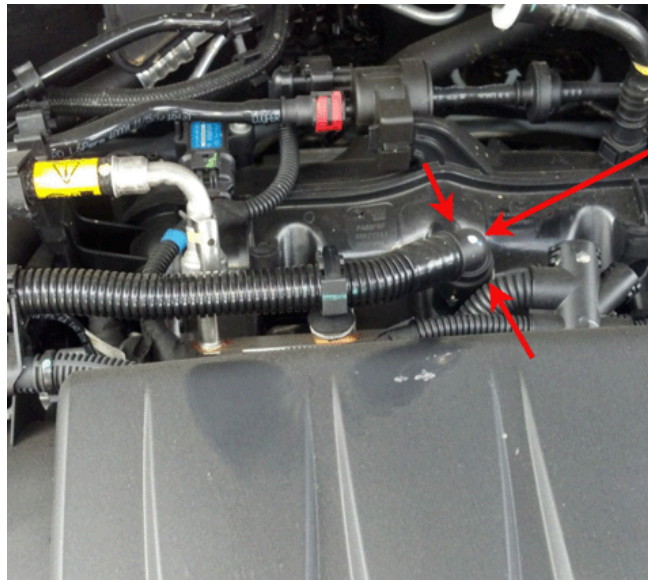
3814777

Check for a missing or improperly seated intake manifold Non Return Valve that may have damaged the PCV orifice diaphragm. (See pictures below for inspection procedure).

If the intake manifold Non Return Valve is missing or not properly seated, then replace the intake manifold assembly, Check the PCV orifice for leaking oil or drawing vacuum at idle thru its external port. (The PCV orifice is an integral part of the camshaft cover). (See picture below).

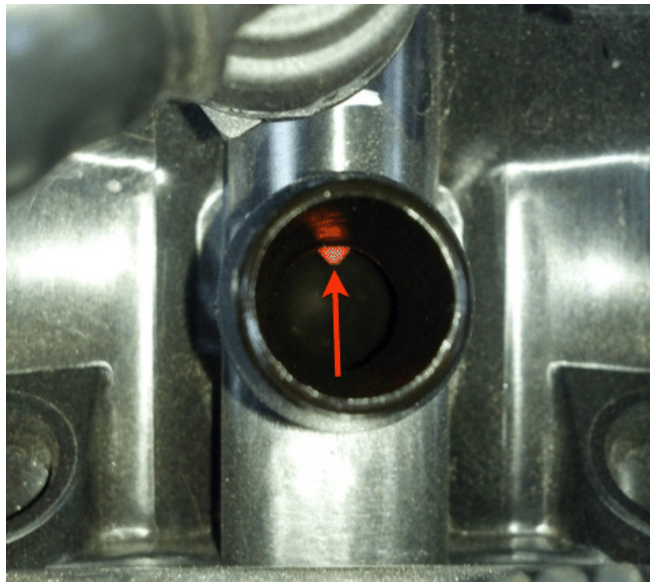
3814782

Properly seated Non Return Valve.
