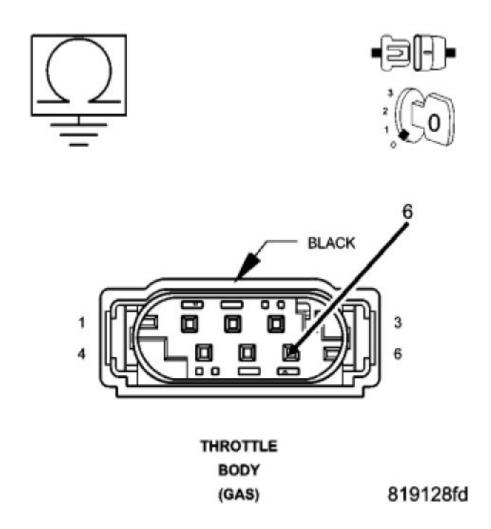
10. (K22) TP SIGNAL 1 CIRCUIT SHORTED TO GROUND

Measure the resistance between ground and the (K22) TP Signal 1 circuit at the Throttle Body harness connector.

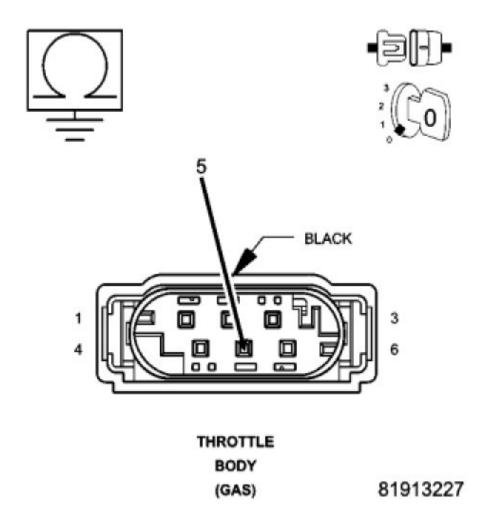
11. (K122) TP SIGNAL 2 CIRCUIT SHORTED TO GROUND

Measure the resistance between ground and the (K122) TP Signal 2 circuit at the Throttle Body harness connector.

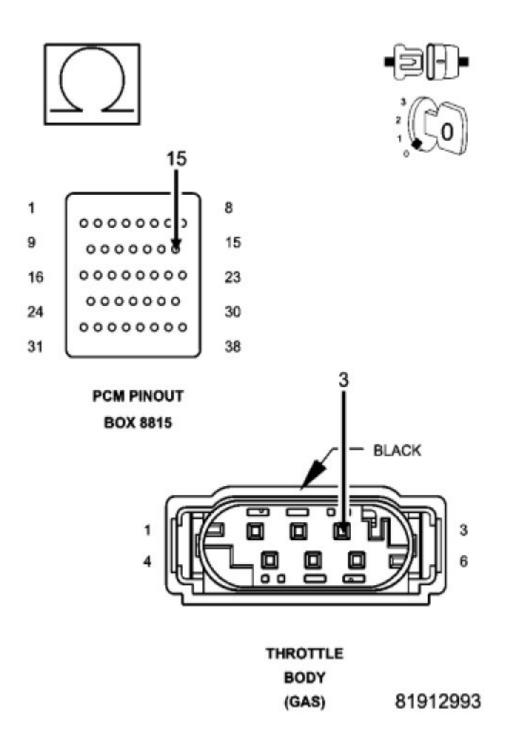
12. RESISTANCE IN THE (K922) TP RETURN CIRCUIT

Measure the resistance of the (K922) TP Return circuit from the Throttle Body harness connector to the appropriate terminal of special tool #8815.

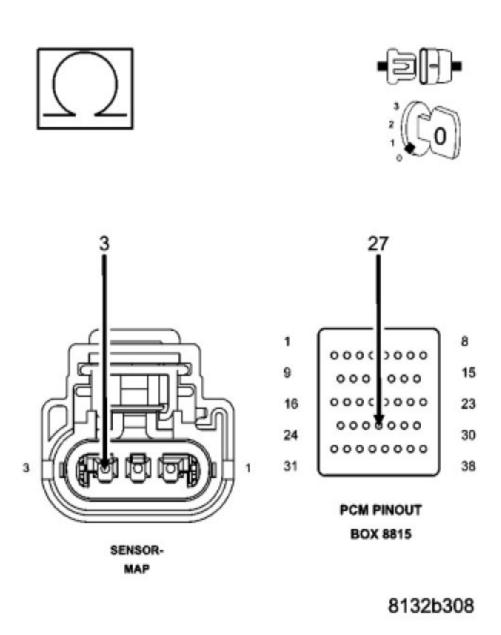
13. RESISTANCE IN THE (F856) 5-VOLT SUPPLY CIRCUIT

Measure the resistance of the (F856) **5-volt** Supply circuit from the MAP Sensor harness connector to the appropriate terminal of special tool #8815.

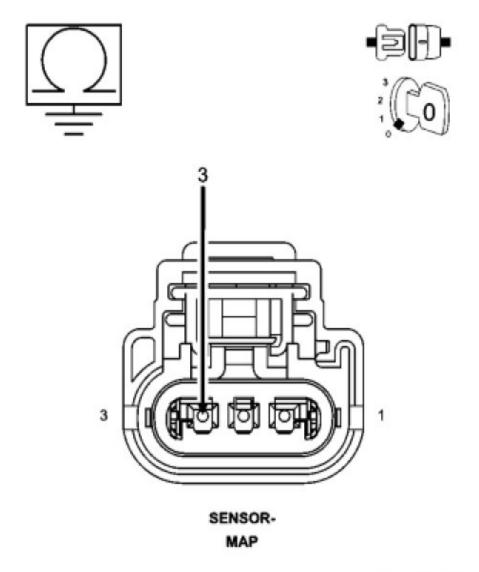
8132b312

14. (F856) 5-VOLT SUPPLY CIRCUIT SHORTED TO GROUND

Measure the resistance between ground and the (F856) **5-volt** Supply circuit in the MAP Sensor harness connector.

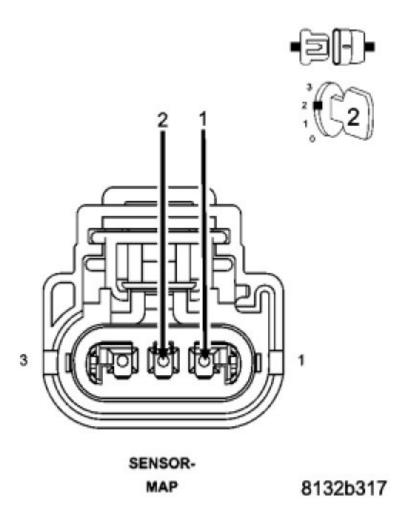
15. MAP SENSOR

Connect a jumper wire between the (K1) MAP Signal circuit and the (K900) Sensor ground circuit in the MAP Sensor harness connector.

Does the scan tool display MAP voltage from approximately 4.9 volts to below 0.5 volt with the jumper wire installed?

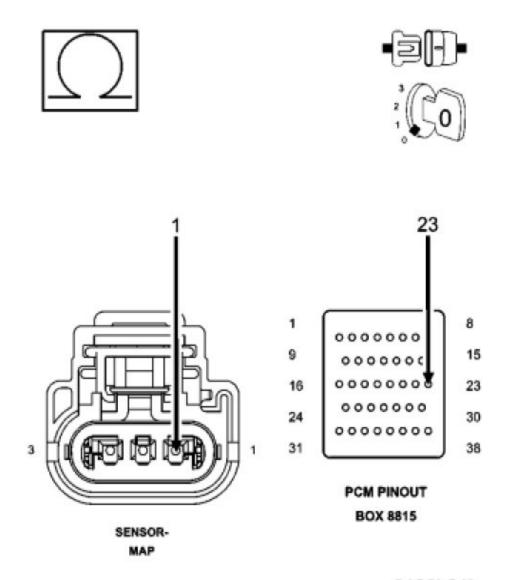
16. RESISTANCE IN THE (K1) MAP SIGNAL CIRCUIT

Measure the resistance of the (K1) MAP Signal circuit from the MAP Sensor harness connector to the appropriate terminal of special tool #8815.

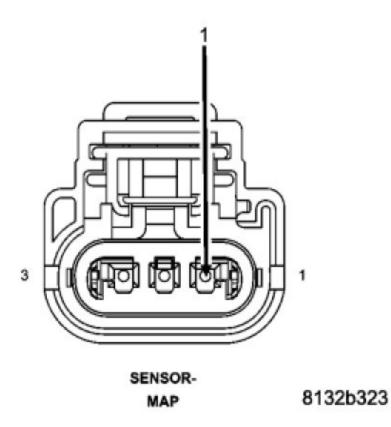
17. (K1) MAP SIGNAL CIRCUIT SHORTED TO GROUND

Measure the resistance between ground and the (K1) MAP Signal circuit at the MAP Sensor harness connector.

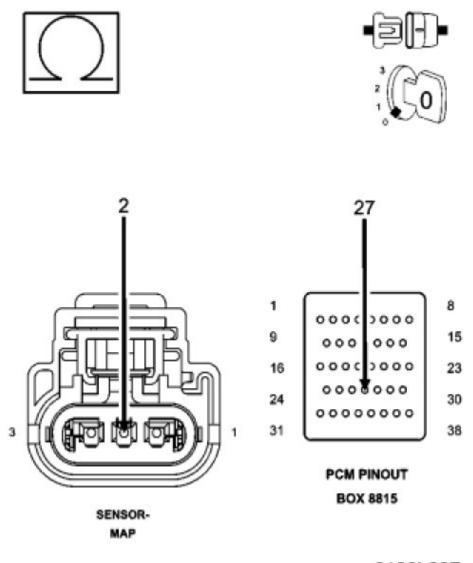
8132b327

18. RESISTANCE IN THE (K900) SENSOR GROUND CIRCUIT

Measure the resistance of the (K900) Sensor ground circuit from the MAP Sensor harness connector to the appropriate terminal of special tool #8815.
